RPE ENGINEERING SERVICES

13 September, 2004

ref. 04122c5

re: **Multiple Directional Wheel**

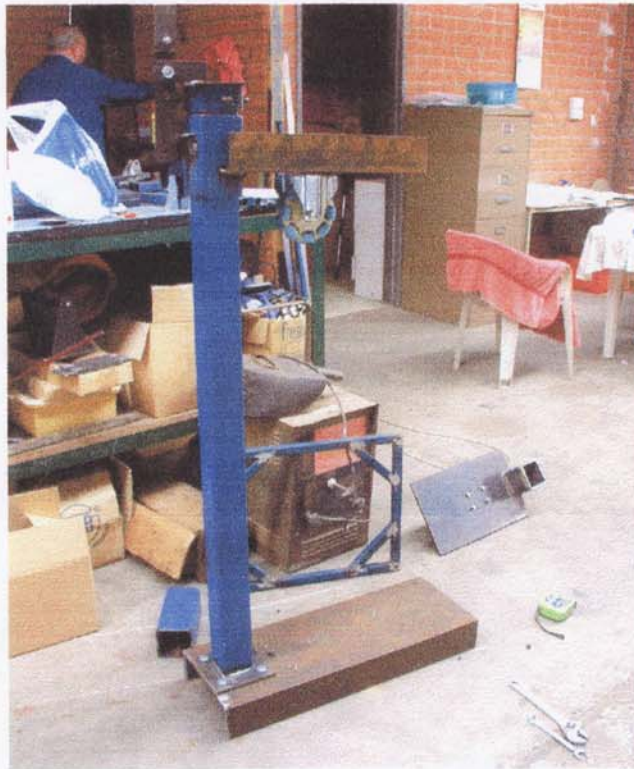
Figure 1 – Drop test rig

The rig is used to drop the wheel under test from a height of one metre onto a steel plate, by activating a release handle holding the wheel and its mountings in place. The total mass of the drop assembly, incorporating the wheel under test, the steel bracket to which it is fixed, and its mountings, is 10 kg. It is estimated that the force applied to the wheel on impact is in the order of 50 kN.

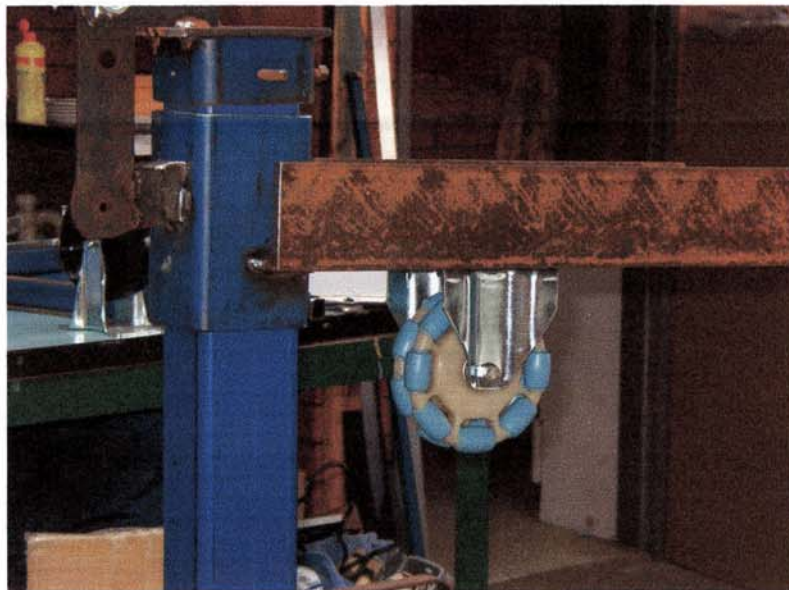
Figure 2 – Rotarola Wheel in drop-test rig

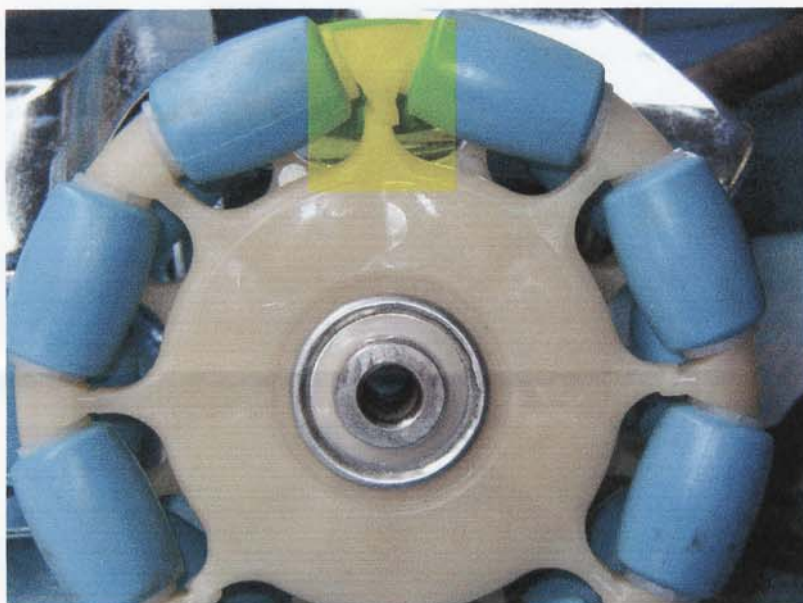
The Rotarola wheel showed no signs of distress, either visually, or in terms of its operation, after the first or second drops. The third drop resulted in some cracking in the wheel 'spokes', at the location shown in Figure 3. However, both the main axle and the rollers remained relatively free, and, if necessary, the wheel could still be used in this condition, though not indefinitely, and not under heavy loading conditions.

Figure 3 – Rotarola wheel after three drops
(Damaged area highlighted)

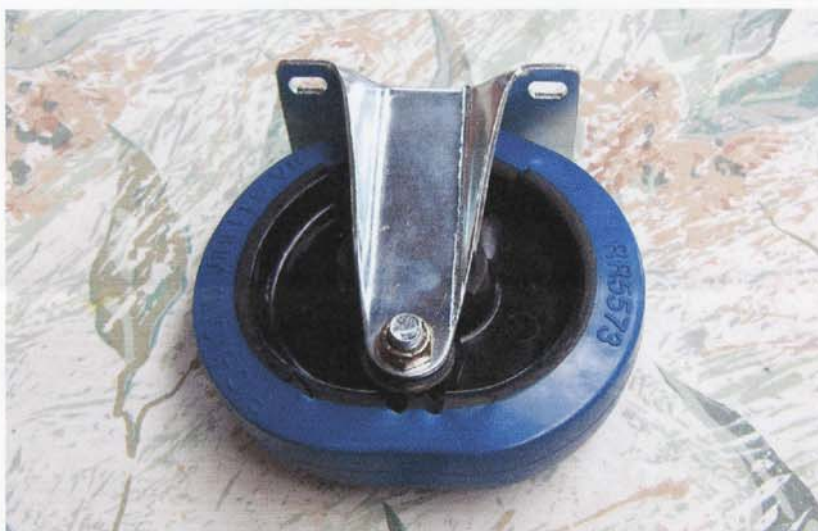
On the first test, this wheel bounced on its resilient tyre, and did not suffer any visual damage, but on rotating it, some minor bearing damage could be detected. On the second test the wheel plate failed (see Figure 4), and the wheel was rendered completely unusable.

Figure 4 – Competitor's wheel after two drops
